Lakeview Family Aquatic Center Waterslide Structural Assessment Report

Allen Taylor, S.E. ATSE Consultants, LLC 4/21/2011

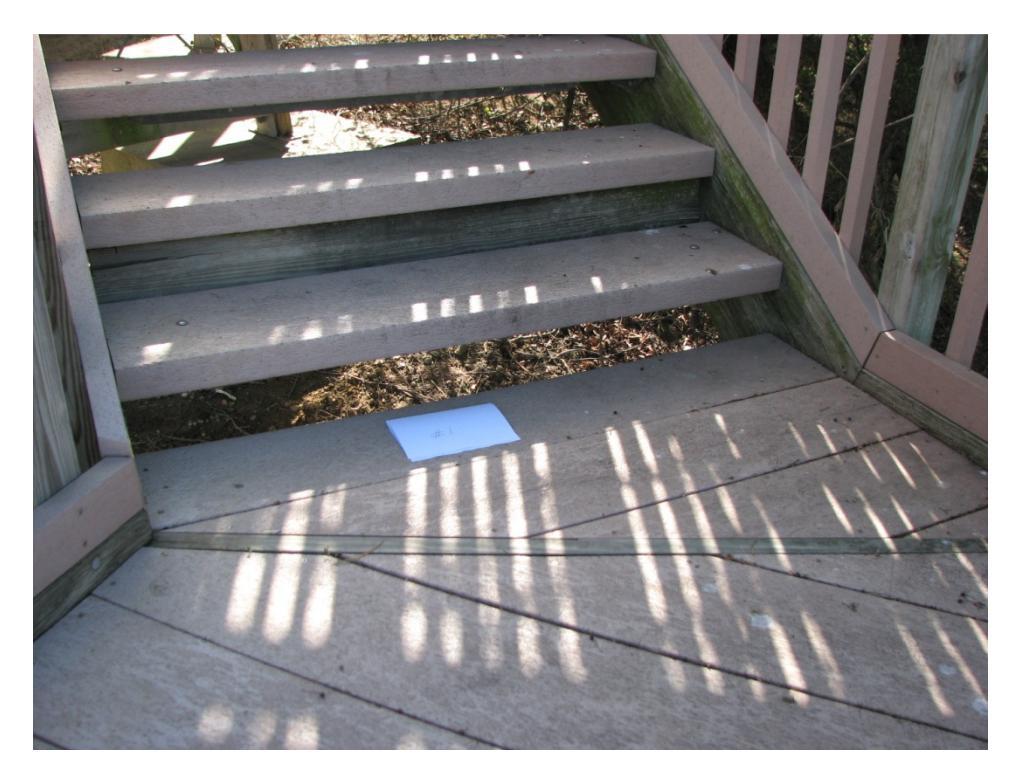
Location	Deficiency	Action	Image
Landing #1	Last composite deck plank on landing is very bouncy.	Reinforce the	Image #1
		underside of deck plank	
Landing #3	The North, South, East and West ends of 4x12 platform	Replace 4x12 the two	Images
	timbers have moderate to severe decay with exposed	(2) members	#2,3,4,&5
	end grain.		
Landing #3@	2x10 beam under the landing has a large split on the	Replace the 2x10	Image #6
Pier B-19	bottom of the beam just below the last bolt.

Image #1 (Decking Very Bouncy)

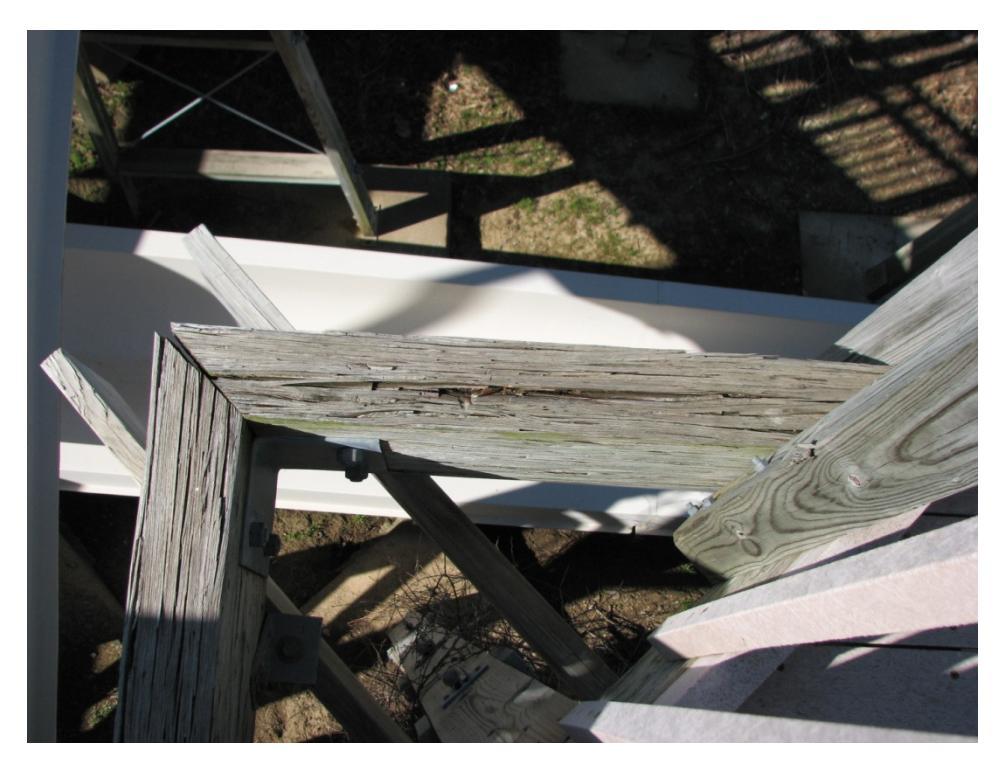
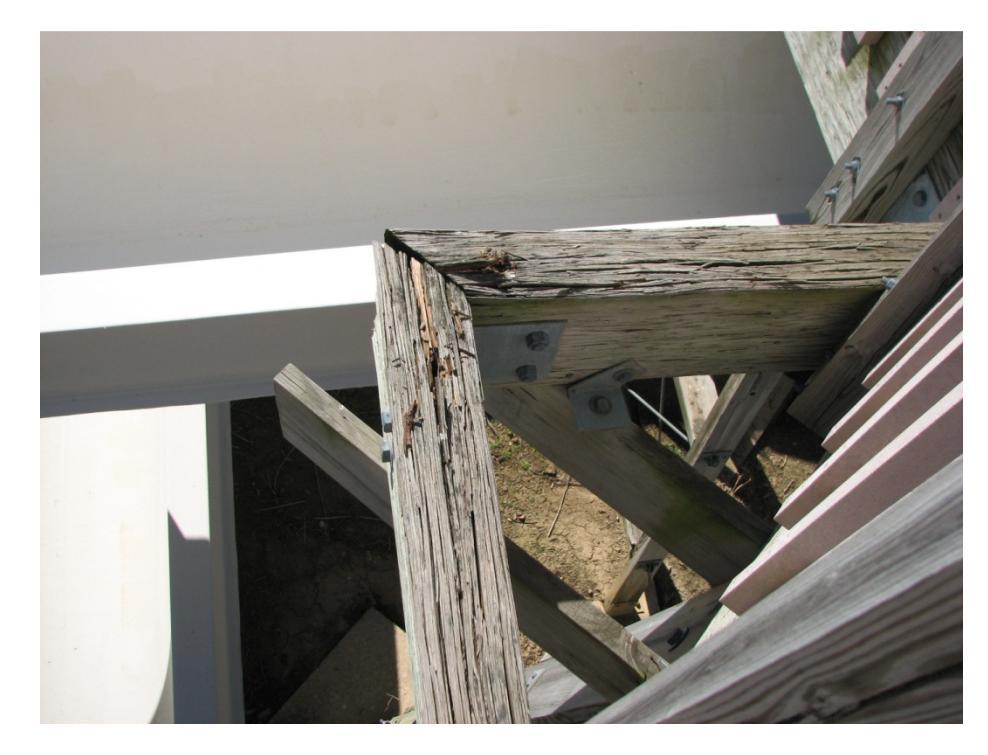
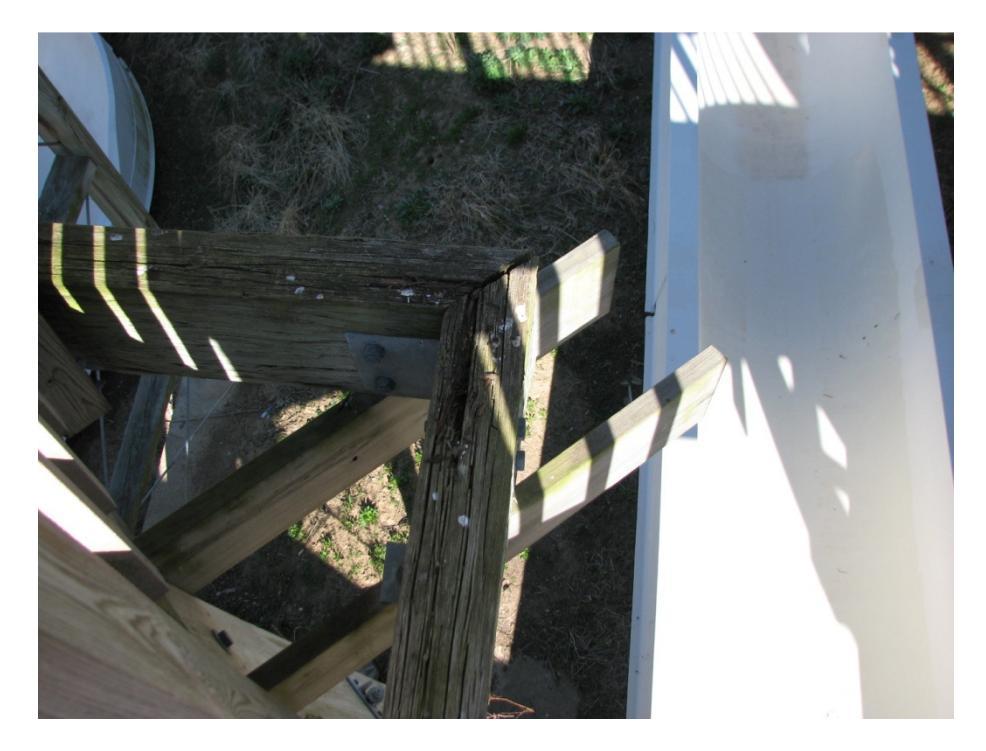
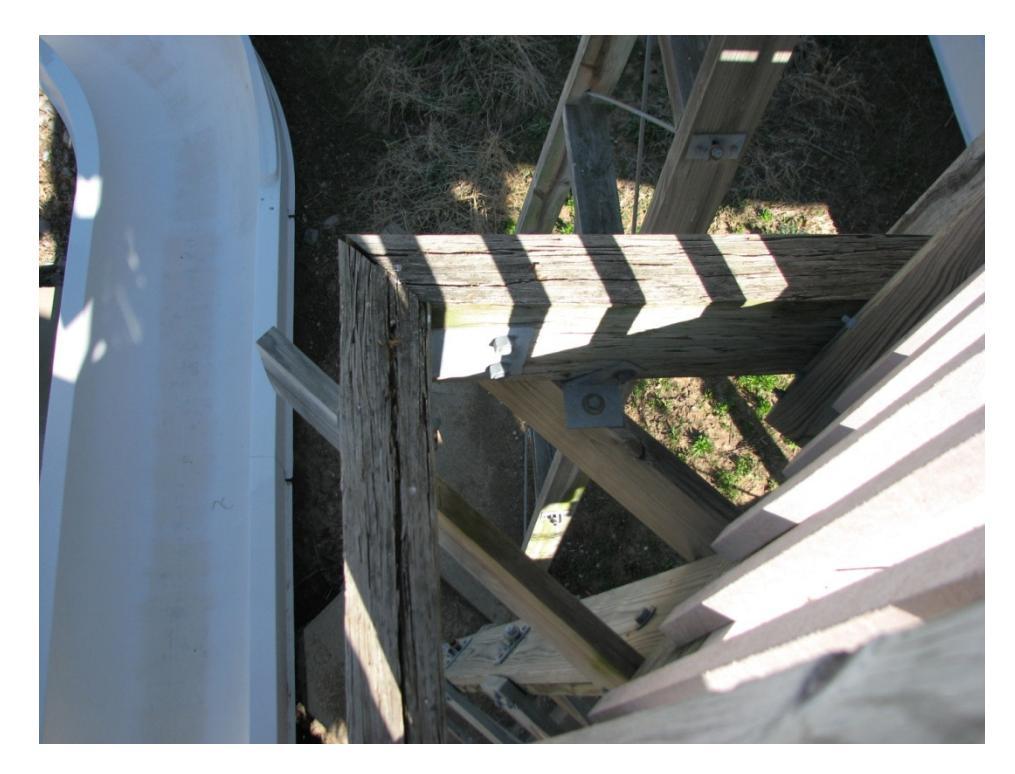
Image #2 (Landing #3 4x12 Beams Need Replaced)

Image #3 (Landing #3 4x12 Beams Need Replaced)

Image #4 (Landing #3 4x12 Beams Need Replaced)

Image #5 (Landing #3 4x12 Beams Need Replaced)

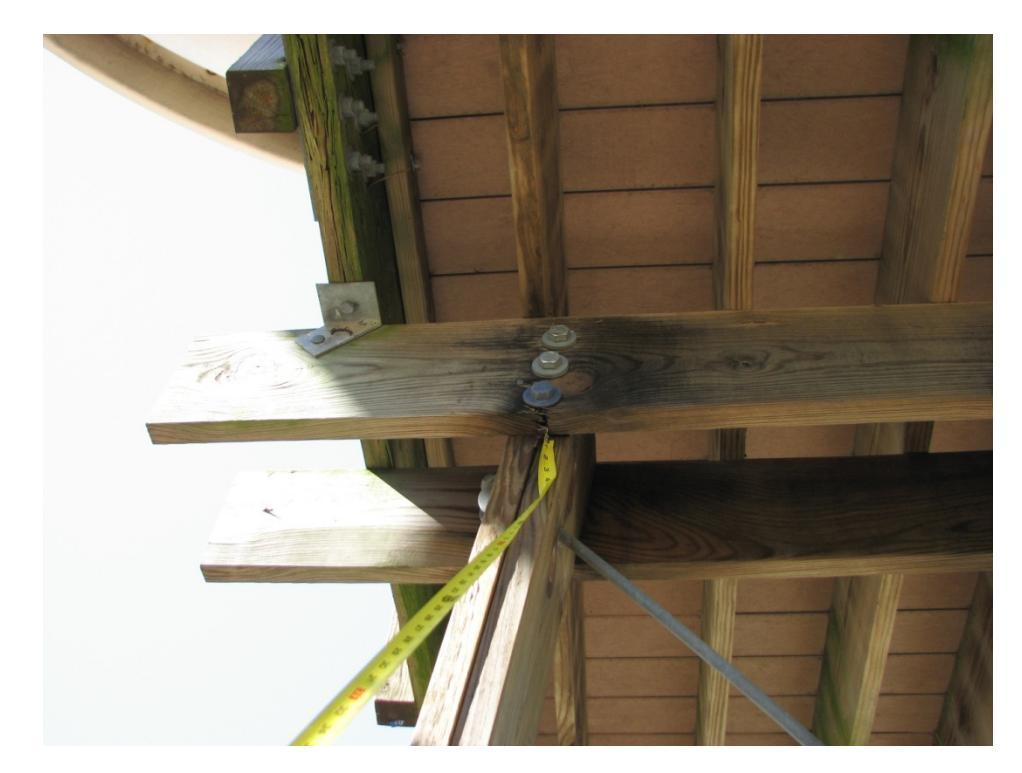
Image #6 (Landing #3 2x12 Beams Needs Replaced)

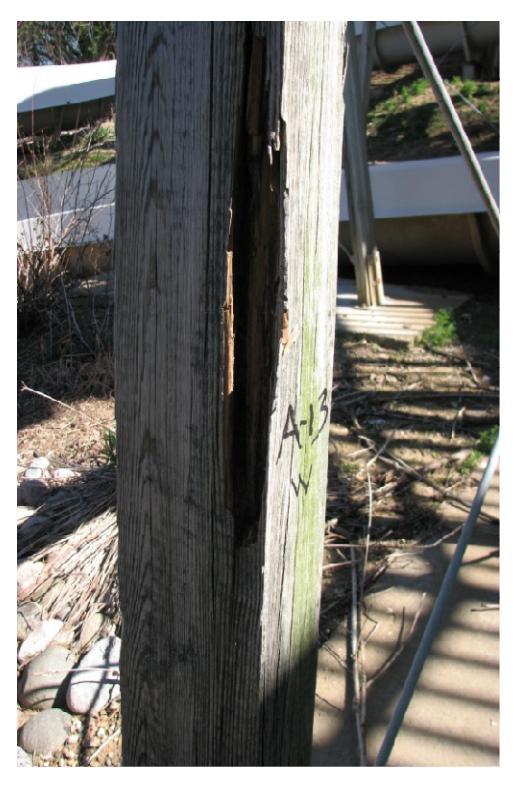
Location	Deficiency	Action	Image
A-13 Post	West support post has moderate to severe decay	Replace post	Image #7
B-9 Post	Top of North post has severe decay with exposed heartwood	Replace post	Image #8
B-18 Post	Top of South post has severe decay and splitting.	Replace post	Image #9
B-20 Post	Top of North post has severe decay and checking with exposed heartwood	Replace post	Image #10
A-27	Bottom horizontal wood brace has severe decay and splitting, with heartwood exposed	Replace member	Image #11

Image #7 (Post @ A-13 West Leg Needs Replaced)

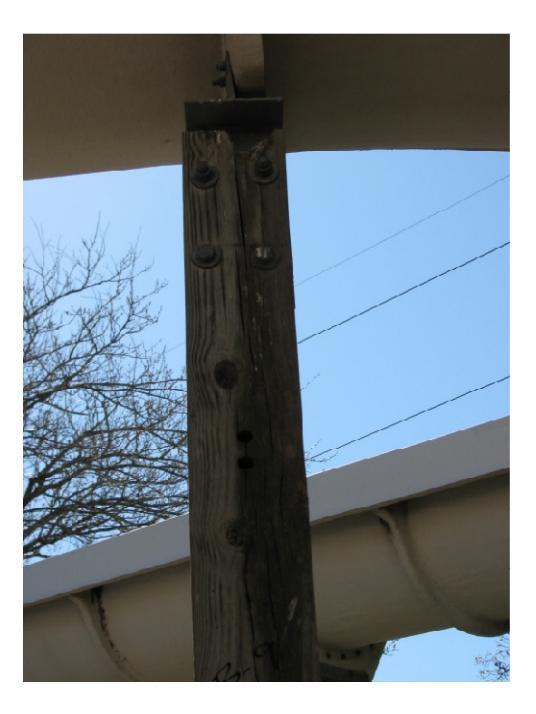
Image #8 (Post @ B-9 North Leg Needs Replaced)

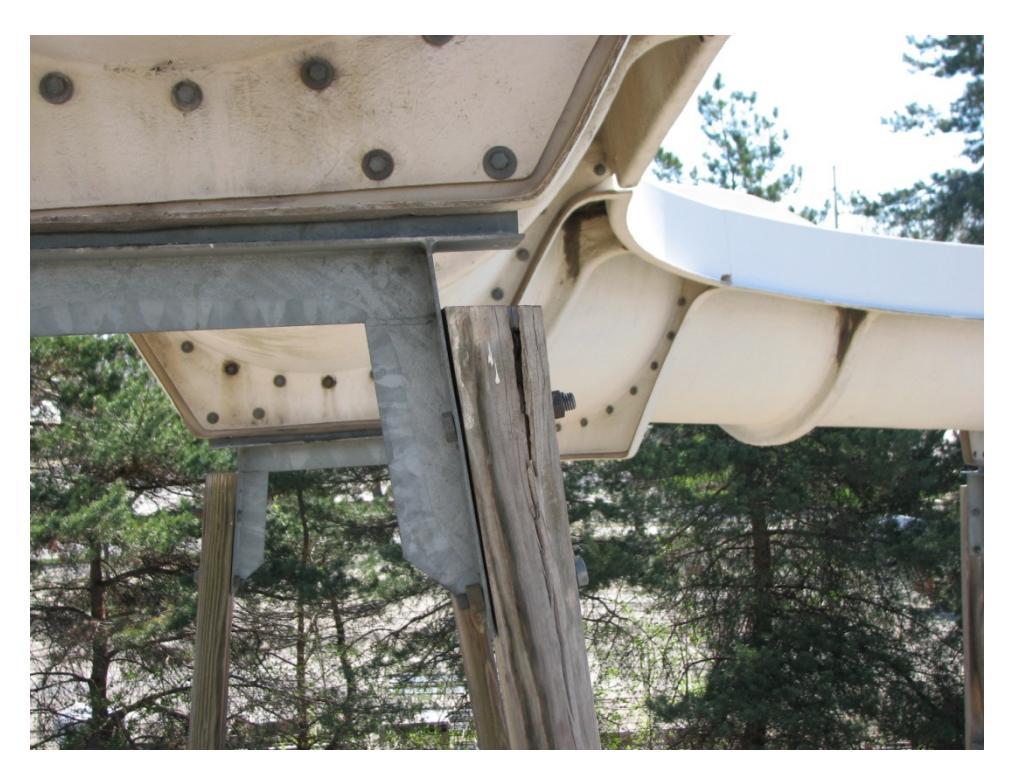
Image #9 (Post @ B-18 South Leg Needs Replaced)

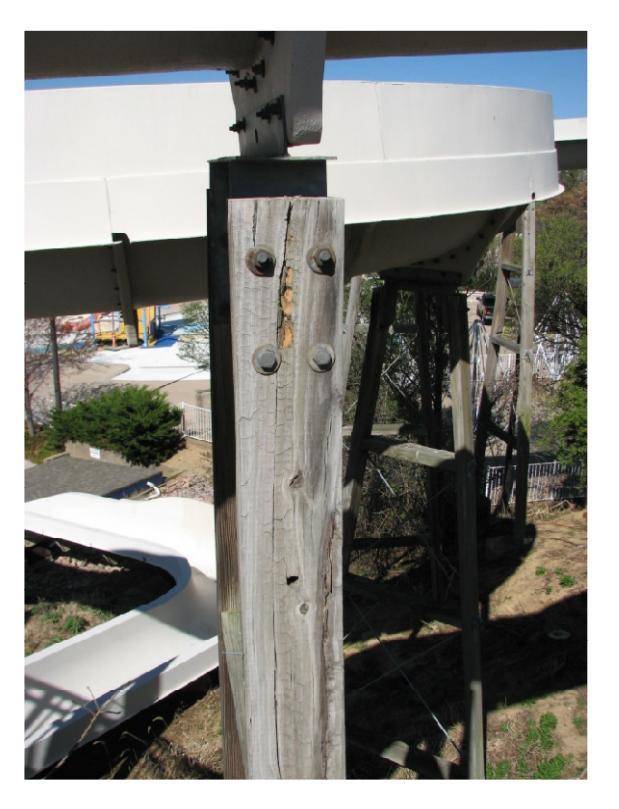
Image #10 (Post @ B-20 North Leg Needs Replaced)

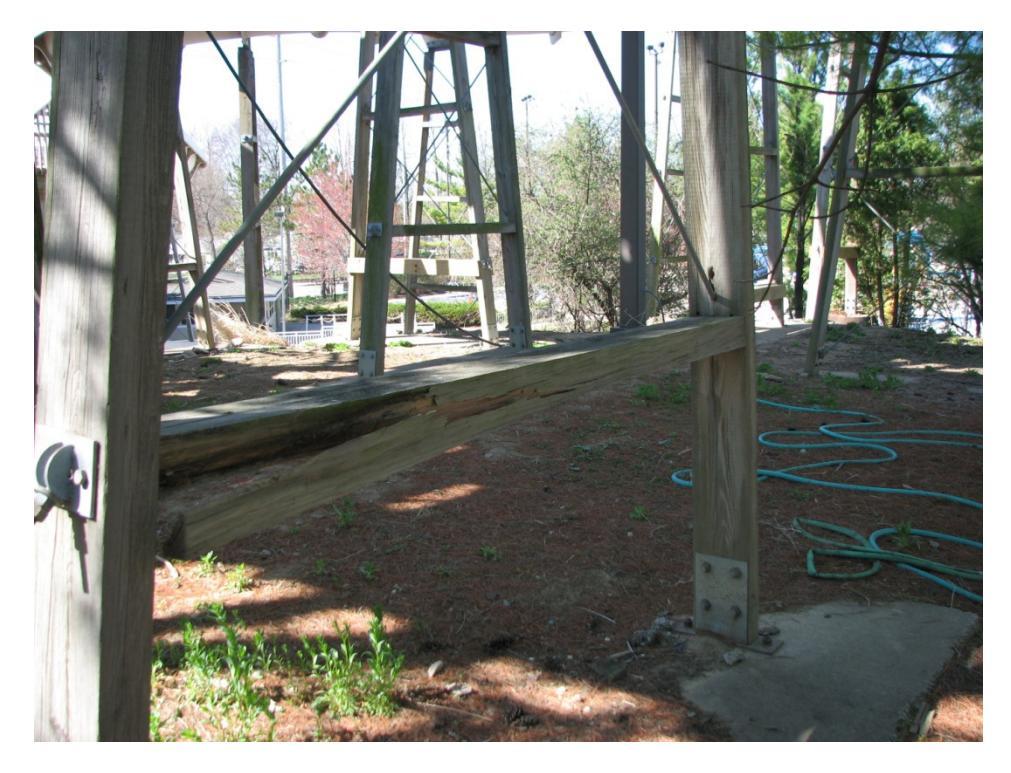
Image #11 (Horizontal Brace @ A-27 Needs Replaced)

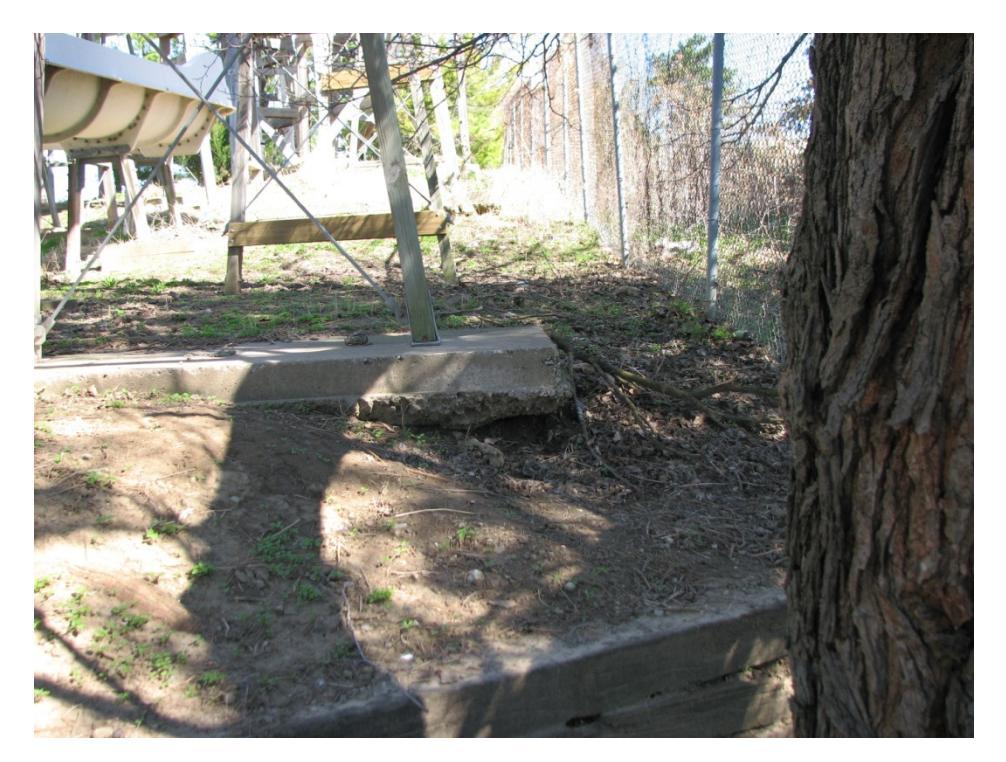
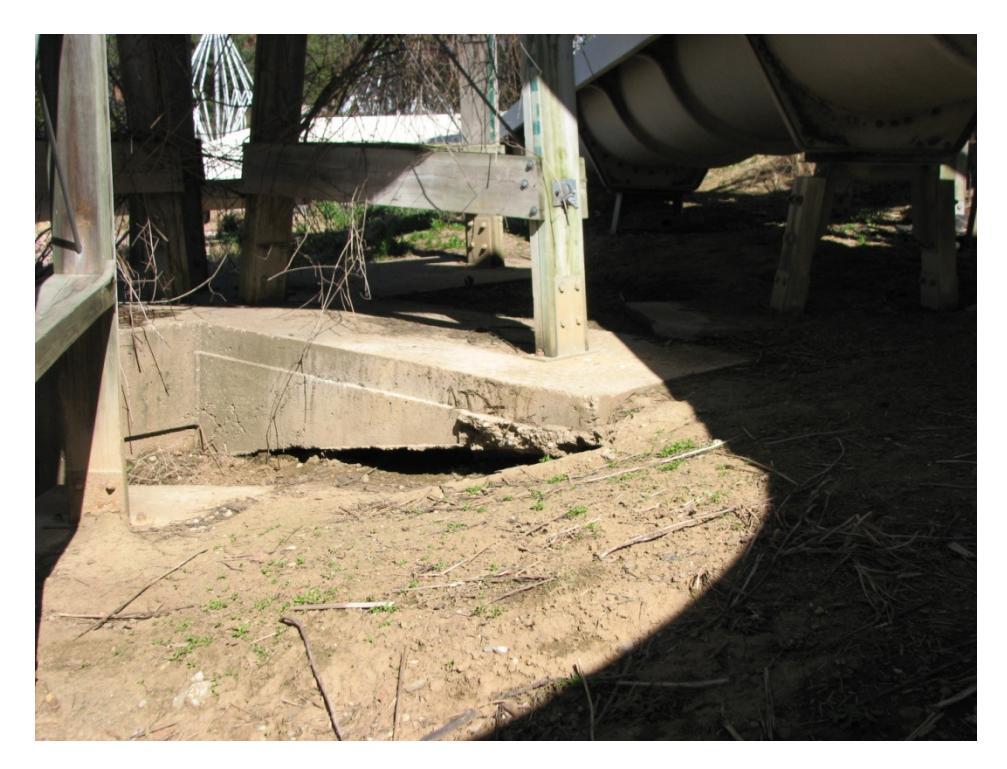
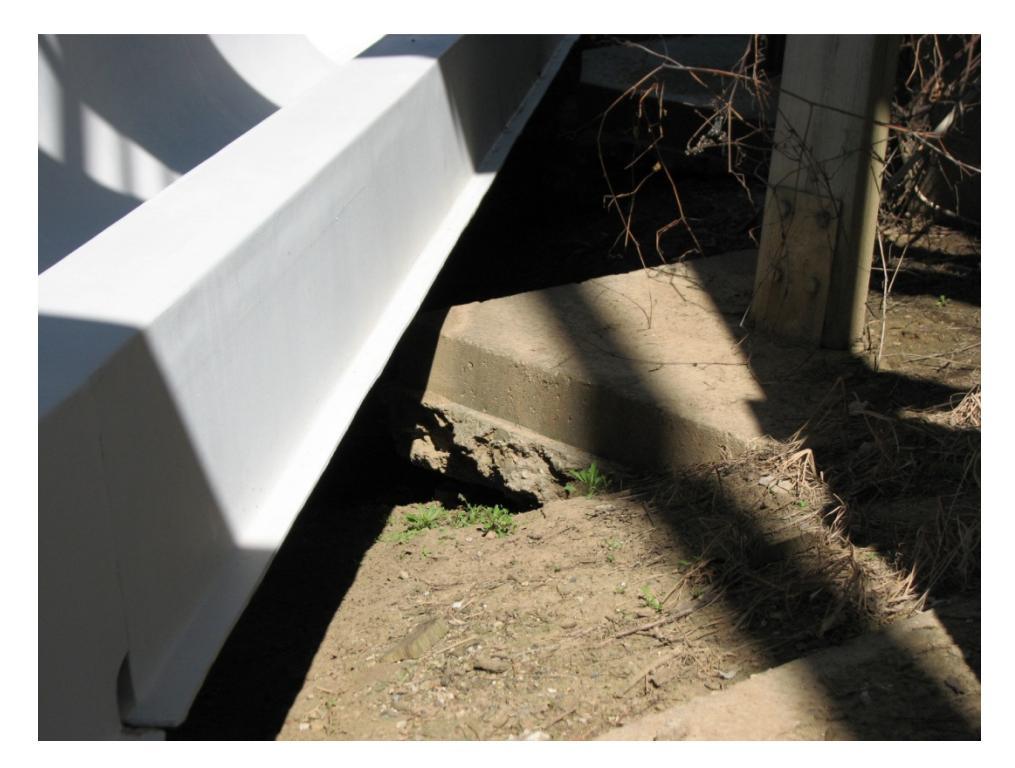
Location	Deficiency	Action	Image
Foundation	A few of the foundations pads have experienced some	Backfill undermined	Images
Pads	undermining as a result of poor drainage.	locations with granular	#12,13,&14
		fill and correct drainage	
		issues.	
Timber Post	Many of the steel base anchorage plates that attach to	Clean off the dirt and	Image #15
Steel Base	the foundations are covered in dirt and debris. This	debris and prevent	
Anchorage	type of exposure accelerates corrosion to both the	reoccurrence.	
	plate and the ends of the post

Image #12 (Foundation Undermined)

Image #13 (Foundation Undermined)

Image #14 (Foundation Undermined)

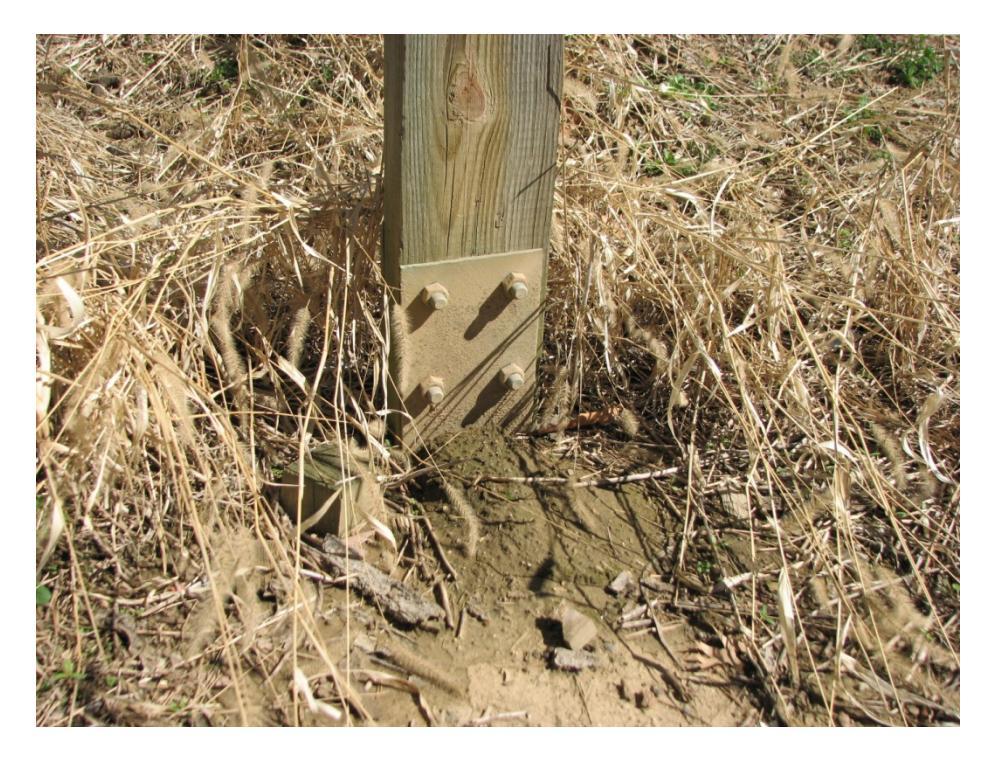
Image #15 (Burring Steel Base Anchorage, Remove Debris)
